Gold King Mine Spill Response

New Mexico's Response to the Gold King Mine Spill

June 9, 2016

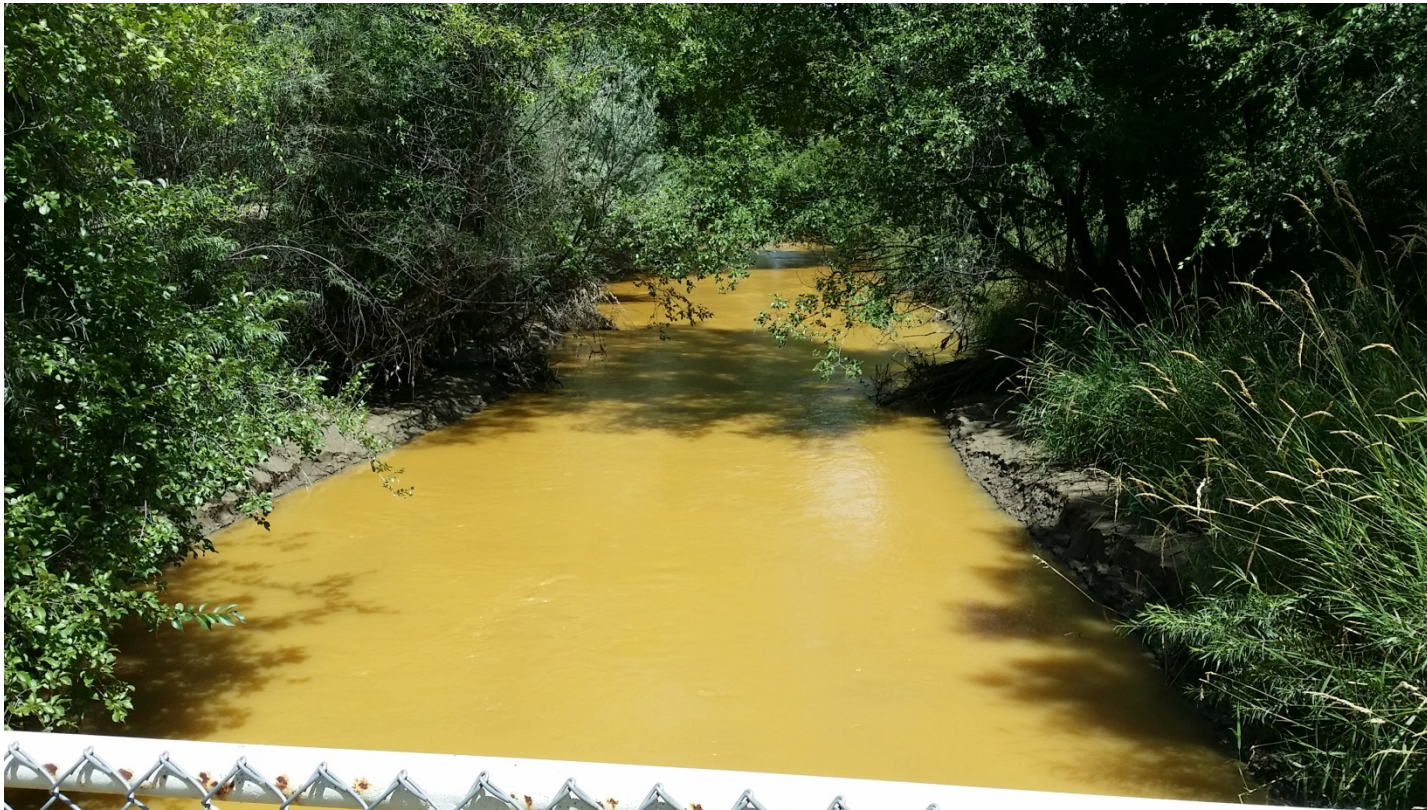
**Willett Irrigation
Ditch**

**Farmington, NM
August 8, 2015**

- **Some, but not all, irrigation ditch intakes could be closed prior to arrival of the plume**
- **All ditches were flushed with river water for 12 hours, without irrigation diversions, to wash spill sediment back into Animas River**
- **Drinking water system intakes on the Animas River were not opened until after the irrigation ditches had been flushed**

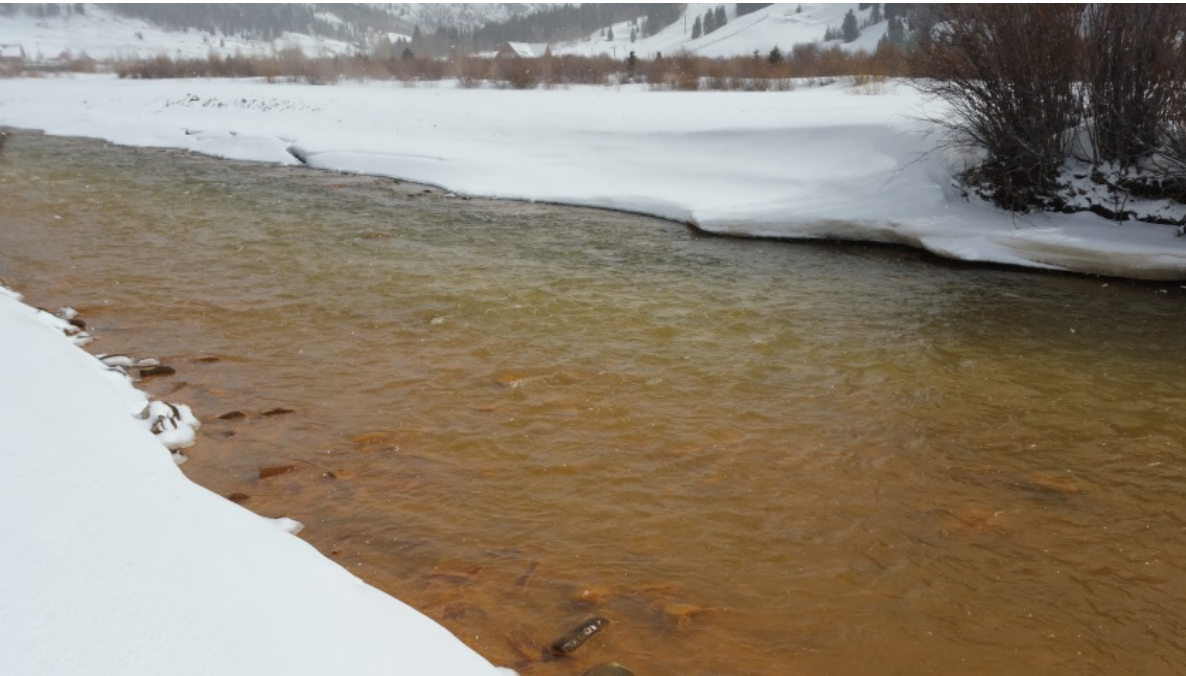
**Animas River
near Silverton,
March 7, 2016**

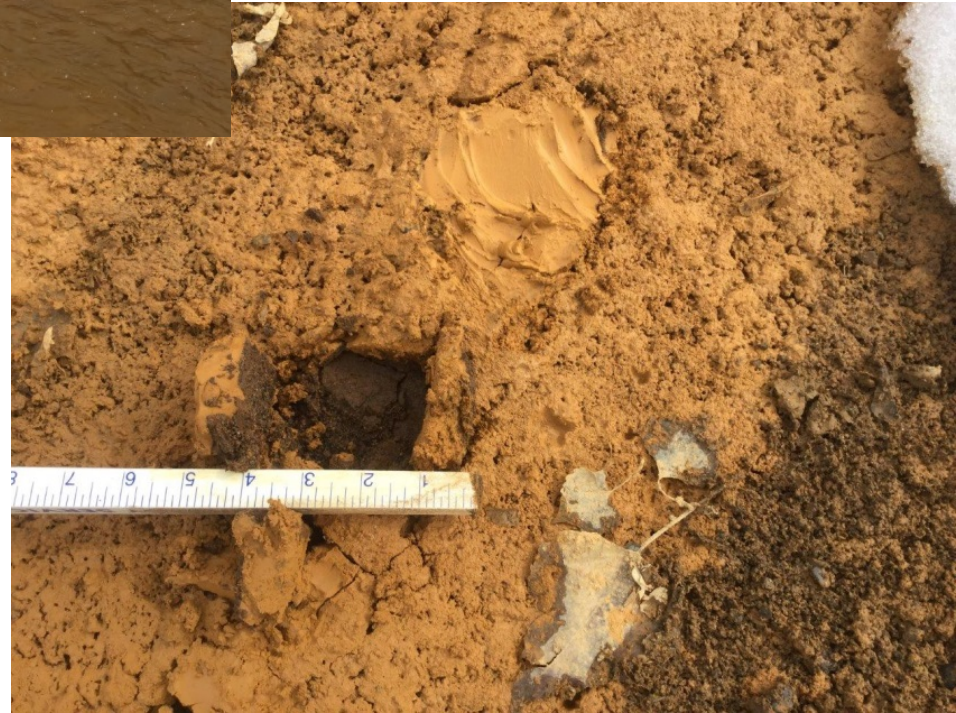
**Animas floodplain near Durango,
Feb. 18, 2016
3,100 mg/kg lead**
